In programming device on M1882, programming error tends to be occurred due to recent shrink device.  
At first, Please check your target device and “device info” <Ctrl+F1> on control software( PG4UW.exe) of M1882.

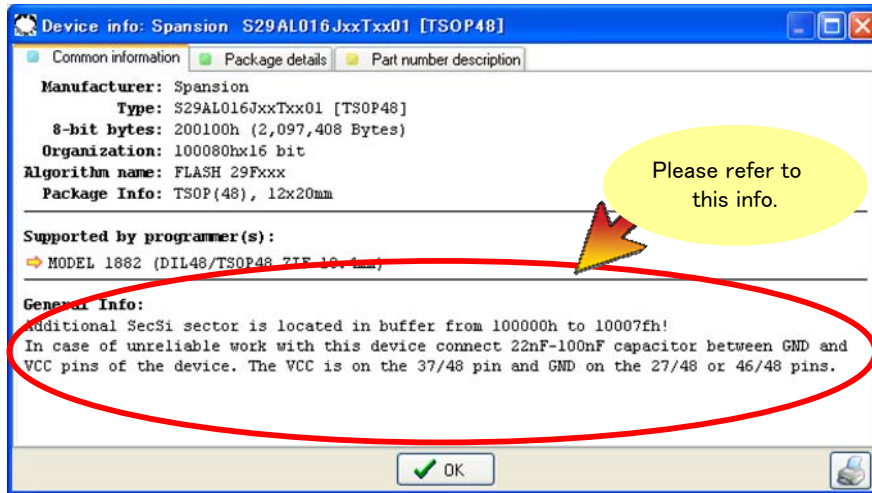
Example: “Device info”

In case, the following description is expressed,

Since suitable location depends on device name. Please follow “Device info” of your target device.

To avoid this phenomenon, programming error tends to be not occurred by connecting capacitor on socket adapter.

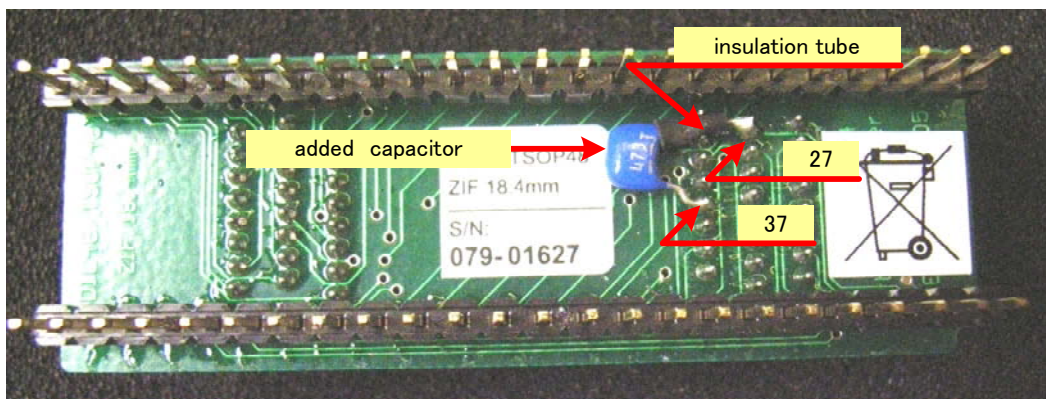
Example: Way to attach capacitor to socket adapter. S29AL016JxxTxx01 [TSOP48]

Socket adapter : DIL48/TSOP48 ZIF 18.4mm
